GSM-R

Incident Resolution Guide for GSM-R Faults and Failures

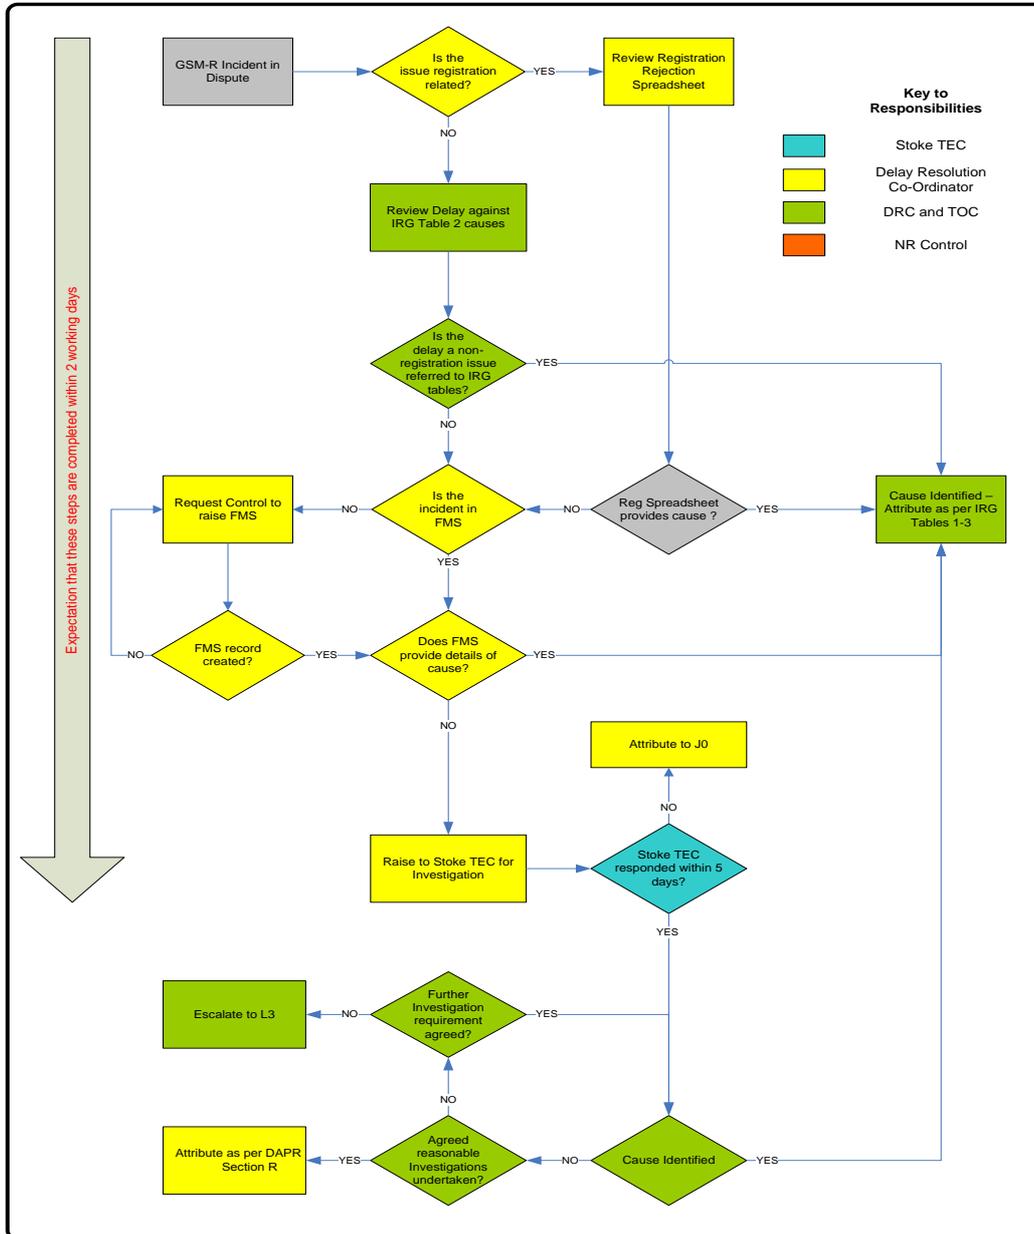
10) Process Flow chart

Note 1: Where an investigation is incomplete, attribution should be made to the Access Party from which the required information, relevant to the prime cause, was not provided.

Note 2: When both parties agree that an investigation has been concluded, and no cause has been identified, the incidents will be coded to J0 (zero) Network Rail responsibility.
